# Follow-Up Review of Early SHCC Applications in Japan

**Abstract.** This paper discussed some early applications of SHCC to structures in which the authors were involved, describing their outlines and evaluations to date, while presenting various technical ideas related to SHCC. SHCC has been shotcreted for surface repair of concrete hydraulic structures, since around 2005. Premixed SHCC products have since then been progressively enhanced, with the application methods being improved. It has been continuously adopted, with no defects or significant deterioration over time having been reported. In the construction of emergency bays in Hida Tunnel around 2007, multilayer shotcrete lining was adopted, and SHCC was shotcreted as the protective layer for the lining. The follow-up review of the lining conducted in 2015 confirmed that the multilayer shotcrete lining including the thin layer of SHCC provides the desired performance. SHCC has been applied to the bases of new-type noise barriers as protective mortar along Tokaido Shinkansen since 2013. No problems have arisen regarding the renewed new-type noise barriers and the protective mortar (SHCC) for the bases.

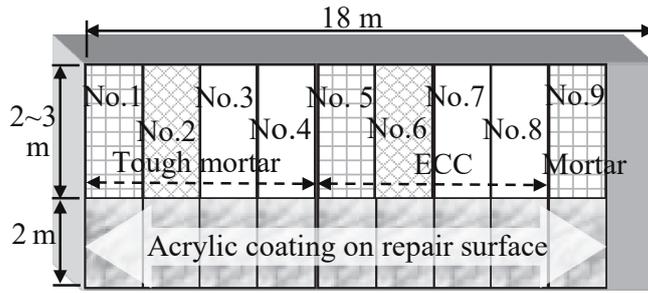
Fig. 1. Block layout of the wall.

This gravity-type retaining wall (approximately 18 m in width and 4 to 5 m in height) constructed around 1970 suffered cracking due to ASR. In April 2003, surface repair was conducted by shotcreting SHCC and repair mortar to a thickness of 50 to 70 mm for the purpose of restoring. Figure 1 shows the block layout of the wall.

Block Nos. 1 to 4 were shotcreted with tough mortar, a type of SHCC, with compressive strength ( $f_c$ ) of 37.6 MPa. The tough mortar contained polyvinyl alcohol (PVA) fibers 12 mm in length and high strength polyethylene (PE) fibers 12 mm in length (1.5 vol % in total). Block Nos. 5 to 8 were shotcreted with ECC containing 12-mm long high-performance PVA fibers (2.1 vol %) with  $f_c$  of 54.2 MPa. Block No. 9 was shotcreted with normal repair mortar with  $f_c$  of 59.3 MPa. The bottom area to a height of 2 m was additionally coated with acrylic. Prior to shotcreting, the wall surface was polished by waterjetting. Welded wire mesh (D 6, SD 295 at 100 mm pitch) was set on Block Nos. 1, 5, and 9. Expanded metal (75 by 203 mm, XS-82) was set on Block Nos. 2 and 6, both at around 10 mm from the wall surface.

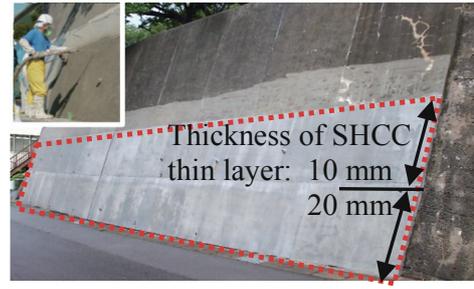
Fig. 2. Thin layer shotcreting of SHCC.

In April 2008, the range from the bottom of the wall to a height of 2.5 m including the acrylic coating was polished by waterjetting, as stain on the acrylic became noticeable. In October 2008, shotcreting of SHCC (tough mortar) on the polished area was demonstrated to participants of an international convention held at this time nearby. The shotcreting thickness was approximately 20 mm from the bottom of the wall to a height of 1 m and 10 mm in the range of 1 to 2 m in height (Fig. 2).

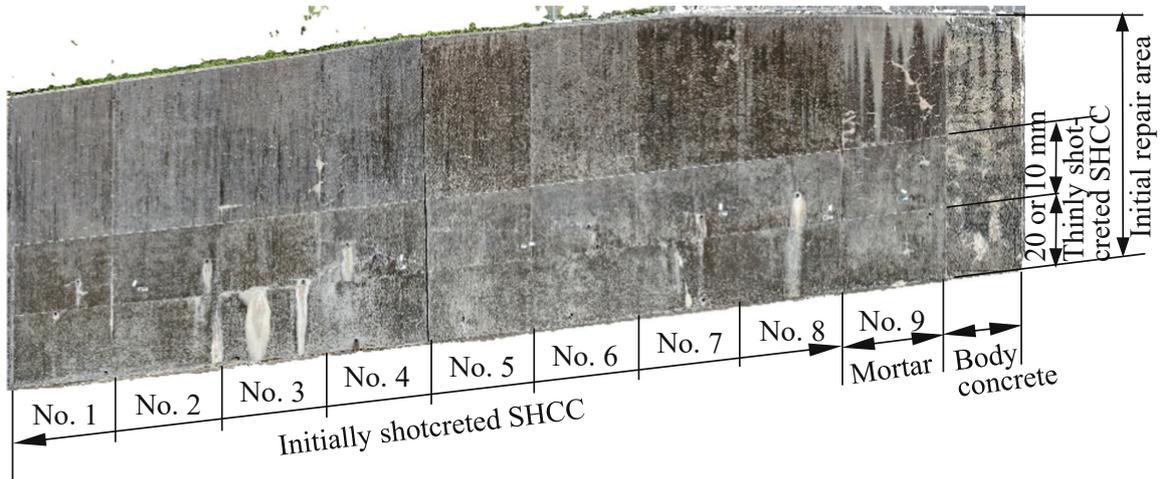
Fig. 3. Image of the retaining wall.

Figures 3 and 4 show normal and thermal images, respectively, taken with a drone-mounted camera in September 2020, which is 17 years after the initial application. These were made by synthesizing 23 images each into orthomosaic images of the wall frontal.

Stain due to efflorescence, etc., was less evident on Block Nos. 1, 2, 5, and 6 where reinforcement was laid out in the SHCC layer in the initial application (Fig. 3). In Block No. 9 (thin-layer SHCC on normal repair mortar), a wide range of delamination was recognized by hammering test and thermal imaging analysis (Fig. 4) under the thin-layer SHCC (10 to 20 mm in thickness), which was shotcreted five years after the initial application. Delamination was also found mainly near the boundaries between Block Nos. 5 to 9. On the other hand, no delamination was found in the initially shotcreted SHCC (the area above the level 2 m from the bottom, 50 to 70 mm in thickness) by hammering test and thermal image analysis.

SHCC was found superior to repair mortar in suppressing crack widening and inhibiting stain due to efflorescence. It was proven appropriate to select the thickness of 50 to

70 mm, instead of 10 to 20 mm, in the initial shotcreting of SHCC onto this size of retaining wall, causing little delamination. The placement of reinforcement (welded wire mesh or expanded metal) was proven more effective, than without, in suppressing the crack width and inhibiting stain due to efflorescence. The restoring effect of acrylic coating over the lower half area after the initial application lasted only around two years.

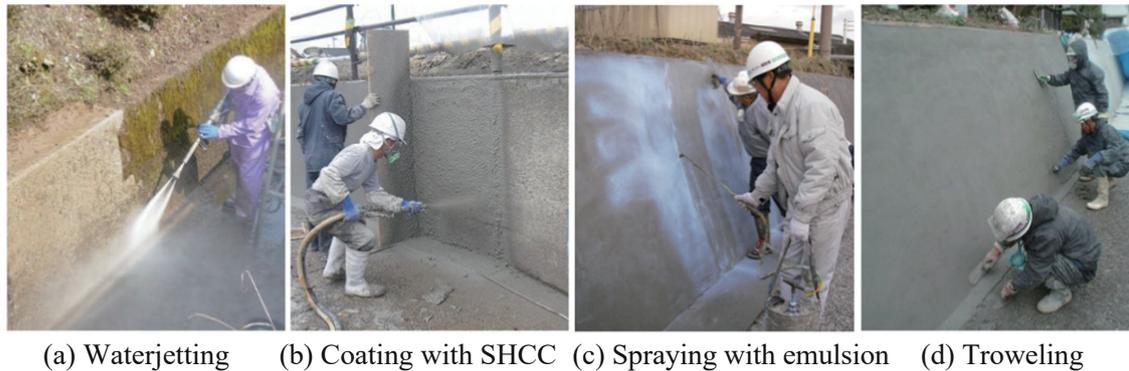
**Fig. 5.** Application of SHCC to agricultural waterway.

Application of SHCC begins with removal of the deteriorated surface to a depth of approximately 1 mm by water jetting, and then follows patching or surface coating with SHCC by troweling (small areas) or shotcreting (Fig. 5). A squeeze pump is used for shotcreting, with the pumping distance being around 50 m at the maximum. After shotcreting with SHCC, the surface is sprayed with an acrylic emulsion at a spread of approximately 150 g/m<sup>2</sup> before troweling. The emulsion improves the trowel slidability, enhancing the efficiency of finishing work, while increasing the initial curing effect due to the formation of the emulsion coating on the finished surface. A method is also adopted for waterway tunnels by which fiber grid reinforcement is placed, onto which SHCC is shotcreted to form a 15 mm coating, to enhance the load-bearing capacity of the existing lining and prevent spalling (Fig. 6).

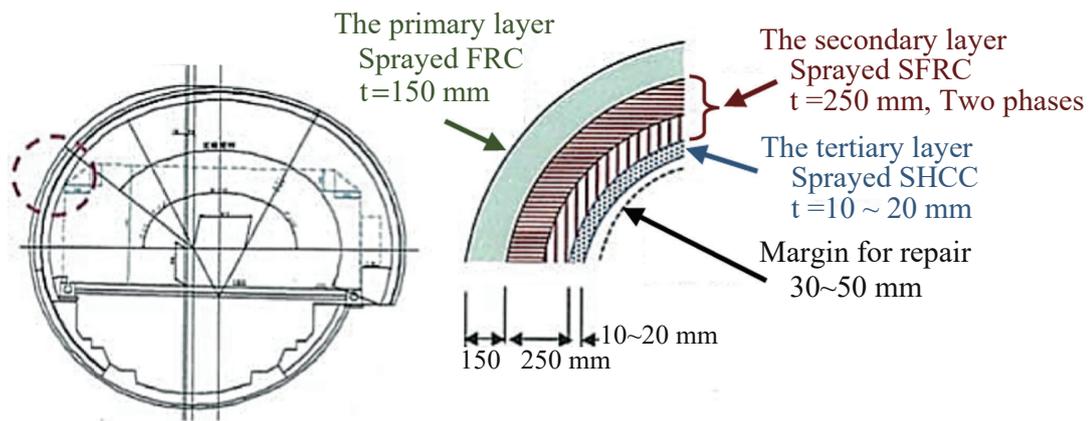
Fig. 7. Multilayer shotcrete lining.

After being completed in January 2007, the main tunnel was widened at 33 points to construct emergency bays. Multilayer shotcrete lining (Fig. 7) was adopted for the walls of 16 of the 33 emergency bays instead of conventional cast-in-place concrete lining, for the first time among domestic expressway tunnels.

Fiber-reinforced shotcrete with  $f_c$  of 36 MPa incorporating 0.75 vol % or 1.0 vol % polypropylene (PP) fibers 32 mm in length was used as the primary support layer to a thickness of around 150 mm after excavation to ensure stability of the excavation site and the surrounding ground.

Steel fiber-reinforced shotcrete with  $f_c$  of 36 MPa incorporating 0.75 vol % or 1.0 vol % steel fibers 30 mm in length was then applied as the secondary layer in two phases to a thickness of around 250 mm in total, to increase the structural performance.

As the tertiary layer, SHCC with  $f_c$  of 40 MPa incorporating 2.0 vol % PVA fibers 12 mm in length was applied to prevent spalling of the secondary layer, prevent corrosion of steel fibers, enhance water tightness, and improve the appearance (smooth the surface irregularities of the secondary layer). The SHCC was shotcreted with a thickness of 10 to 20 mm and then smoothed by surface rolling (Fig. 8).

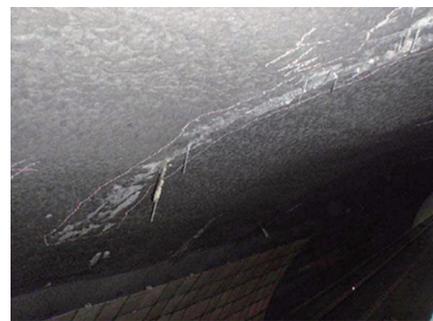
Fig. 9. Typical efflorescence [8].

Figure 9 shows a photograph of typical efflorescence at emergency bay No. 16 where efflorescence and cracks are extensively found. In this bay, the lengths of efflorescence and cracks totaled 20,450 mm and 17,045 mm, respectively. Despite their long extension, no water leakage was found, and the crack width was small, ranging from 0.2 to 0.5 mm, with no sign of progressive growth. Three core samples in total were drilled from emergency bays Nos. 12, 16, and 32 to be subject to compression tests, with the results of all cores exceeding 50 MPa with no delamination at the layer boundaries. Accordingly, the multi-layer shotcrete lining revealed no structural problem about 10 years after application, though with efflorescence and cracks [8].

Since it was confirmed by the follow-up review that the multi-layer shotcrete lining is providing the desired performance, SHCC forming the tertiary layer is also considered to provide the performance initially anticipated.

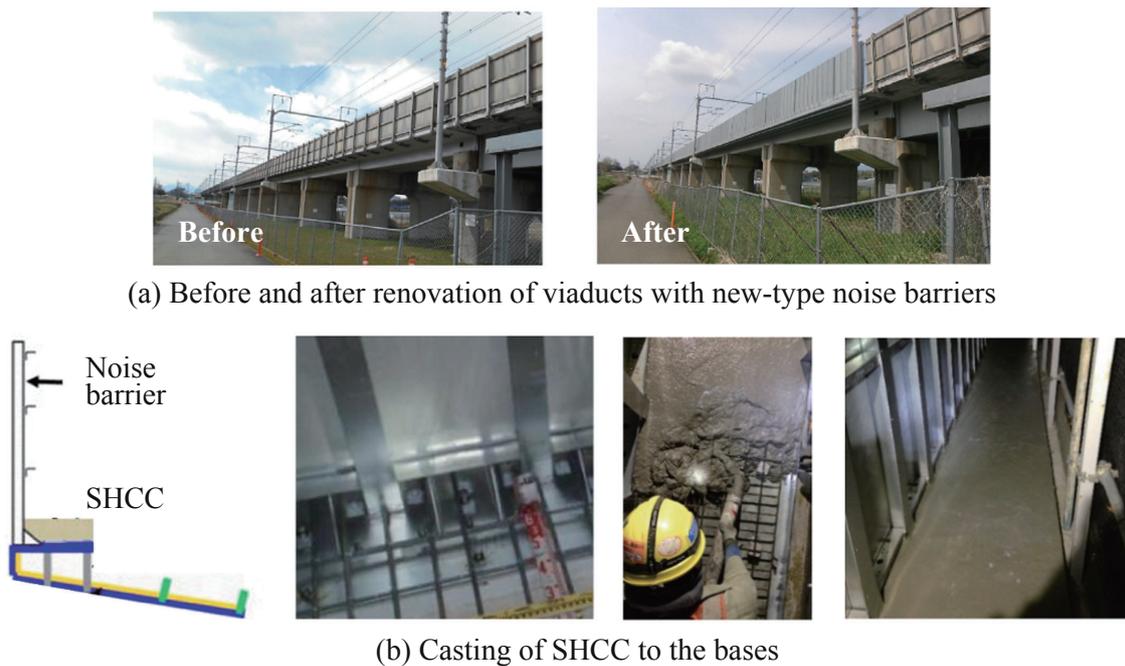
**Fig. 10.** Casting of SHCC to the bases of new-type noise barriers on viaducts.

Tokaido Shinkansen initially had no noise barriers, but they were progressively constructed thereafter, where required, mostly in residential areas. The loads due to the addition of such barriers were therefore not expected in the initial design of the viaducts. In the large-scale renovation project, noise barriers have therefore been replaced with a new type to minimize the effect of wind loads generated by the noise barriers on the cantilever parts of viaducts. In the new-type barriers, anchor bolts that pierce through the cantilever concrete together with the top and bottom steel plates (jackets) strengthen the cantilever members by making them composite structures [10]. As part of the large-scale renovation project of Tokaido Shinkansen, SHCC with  $f_c$  of 40 MPa, containing 2.0 vol % PVA fibers 12 mm in length, has been basically used since 2013 to the bases of the new-type noise barriers for the purpose of suppressing crack width, preventing steel corrosion, and securing inspection passages (Fig. 10). To date, the usage of SHCC on this line has exceeded 10,000 m<sup>3</sup>.

selection of SHCC, which is less prone to cracking. The steel bases for the new-type noise barriers were coated with an epoxy primer to ensure unification with SHCC. It was therefore important to place SHCC within the setting time of the primer.

Replacement with the new-type noise barriers and SHCC placement in the bases are mostly carried out in a short time from midnight to early morning when the trains are out of operation. Experiments have confirmed that vibration equivalent to train running does not adversely affect the bond strength development between steel and SHCC [11]. This substantially relaxed the time limits of SHCC placement.

Ten years having passed since the start of replacement with the new-type noise barriers and placement of SHCC in their bases, no problems have arisen regarding the new-type barriers, the jackets of steel plates of the cantilever segments, or protective mortar (SHCC) for the bases.
